**CANADIAN FORCES
FLIGHT SAFETY INVESTIGATION REPORT (FSIR)**

FINAL REPORT

FILE NUMBER: 1010-CH146475 (DFS 2-4)
DATE OF REPORT: 12 January 2006

AIRCRAFT TYPE: CH146 - Griffon
DATE/TIME: 171443Z September 2003
LOCATION: 5 Wing Goose Bay, Labrador, Newfoundland
CATEGORY: "B" Category Accident

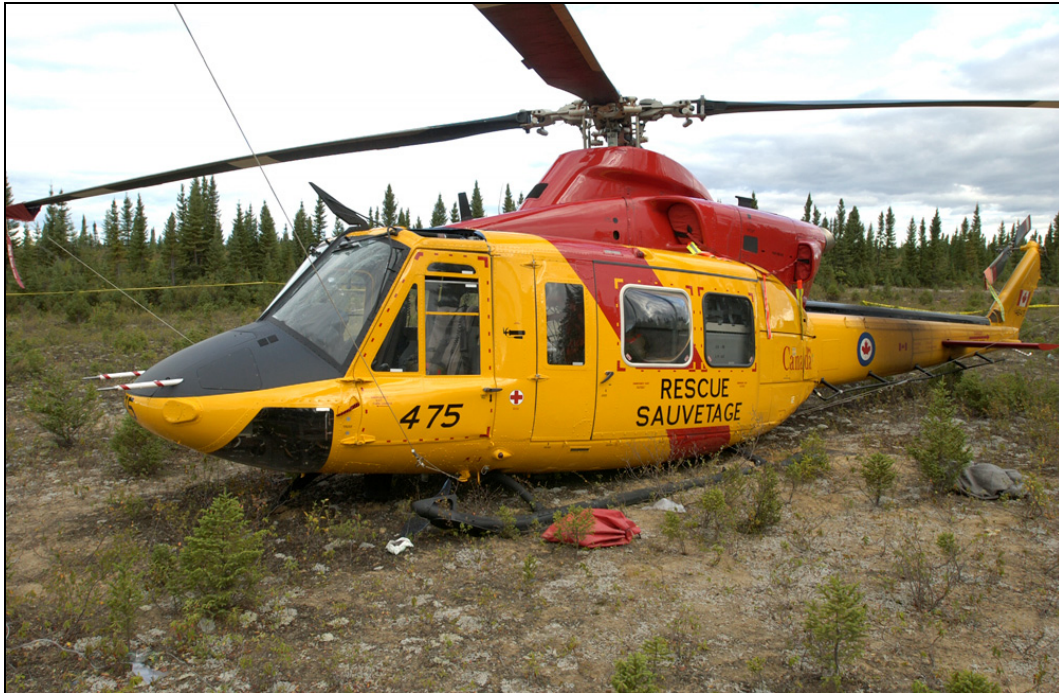
Photo 1: Final Resting Place

The aircraft, CH146475, sustained “B” category damage. There was extensive airframe damage. The roof segment was severed above the pilots’ doors on both sides, the windscreens were shattered and the entire forward section of the fuselage buckled. The landing skid torque tubes were badly splayed outwards. The lower fuselage was not punctured and there was no fuel spill. The rear fuselage behind the cabin was also buckled with wrinkles and noticeable distortion under the aircraft. The tail boom “stinger” had struck the ground and the tail boom was partially separated from the fuselage (Photo 1 – 4).

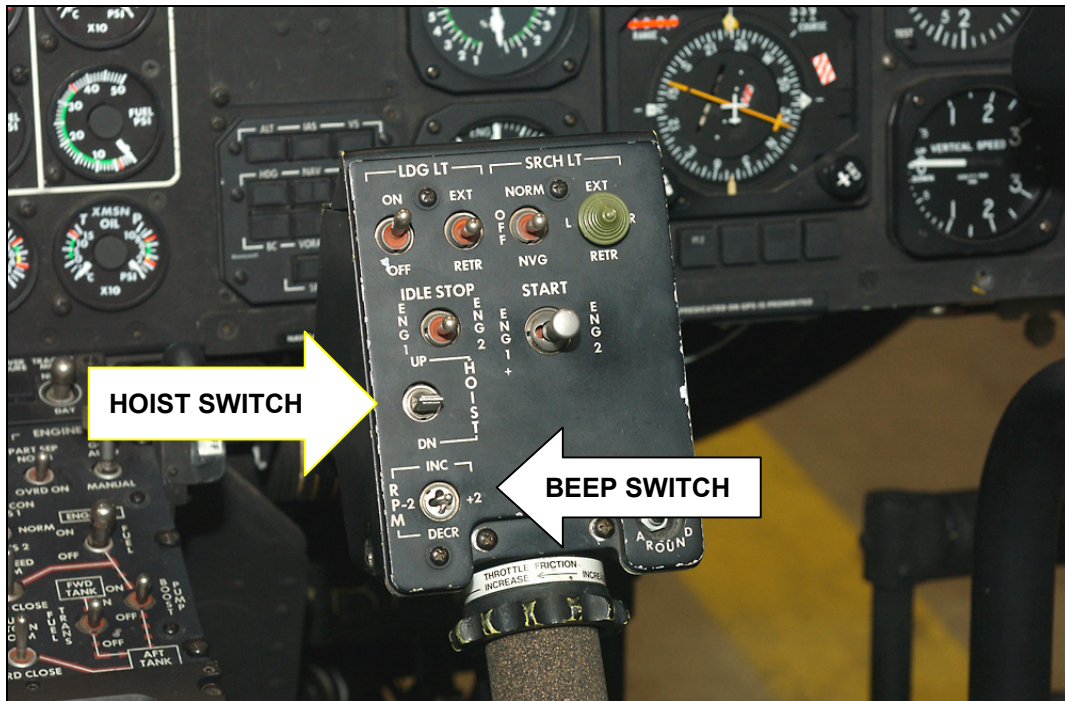
Photo 5 – Pilot's collective control box

The right seat collective has several switches located on its collective control panel. It includes the pilot hoist override switch and the main rotor RPM beep switch (see photo 5), which is located immediately below the pilot hoist override switch.

same way as the hoist override switch, and other than the tactile feel of the switch itself, is difficult to distinguish from the hoist override switch if one is not looking. A second “Beep” switch (for use by the co-pilot) is located on the left-hand collective. Unlike the first pin shaped “Beep” switch, this “Beep” switch is paddle shaped – similar to the hoist override switch (photos 5 and 6).

The co-pilot intended to activate the hoist override switch, however, the “beep” switch was inadvertently toggled. The “beep” switch was inadvertently activated because the co-pilot did not confirm that his finger was resting on the proper switch prior to activation. Instead of visually confirming that he had placed his finger on the right switch, his attention was focussed on the activities of the two FE’s. The close location of the hoist override switch and the “beep” switch, combined with the very similar downward action of the two switches made the erroneous switch selection a high probability. The different shapes of the two switches are not sufficient to prevent such an unsafe act. The flat paddle shape of the hoist override switch and the pin shape “beep” switch are difficult to differentiate using the compulsory two-layer glove worn by aircrew. A visual confirmation of the finger position prior to switch manipulation is the only safe and effective way to confirm that the proper switch is about to be activated.

The similarity of design of the "beep" switch and the hoist override switch, combined with their close proximity can lead to inadvertent activation of the incorrect switch. There is no tone associated with either switch, and tactile feel is similar, so there would be no audible indication to the flight crew if the wrong switch was inadvertently activated. As well, the left and right "beep" switches are of different design with the left "beep" switch being the same type as the hoist override switch.
